# Lia Labeller - Compliance Audit

Lia Labeller

Clean Room

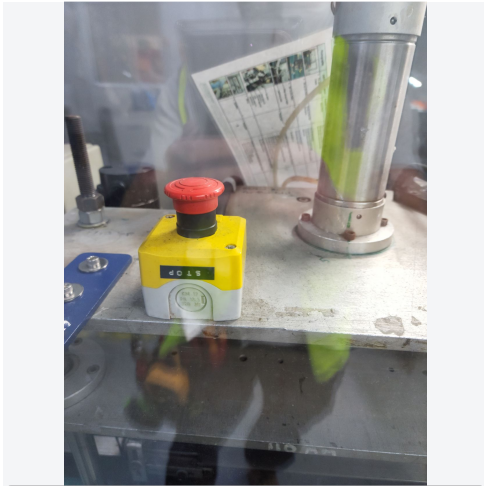
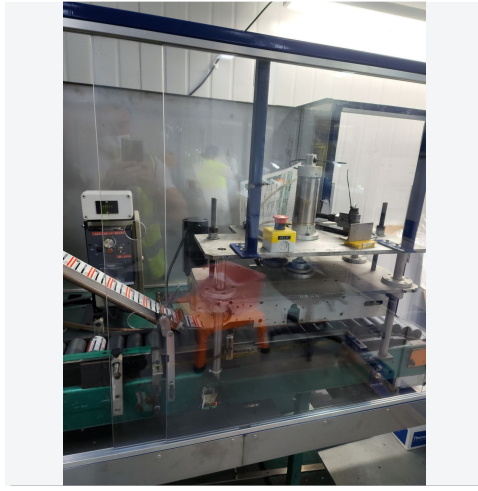
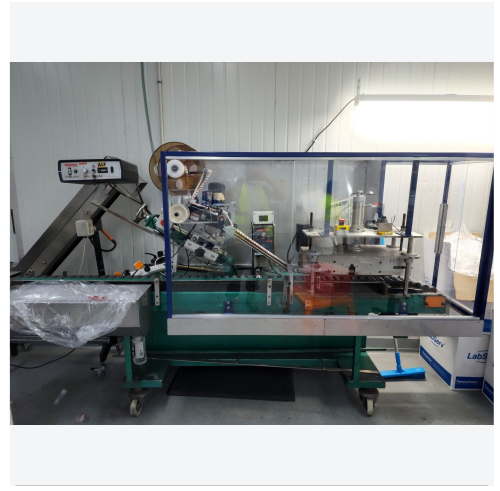
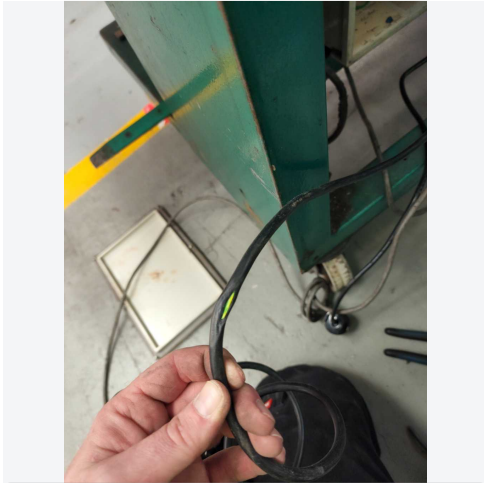
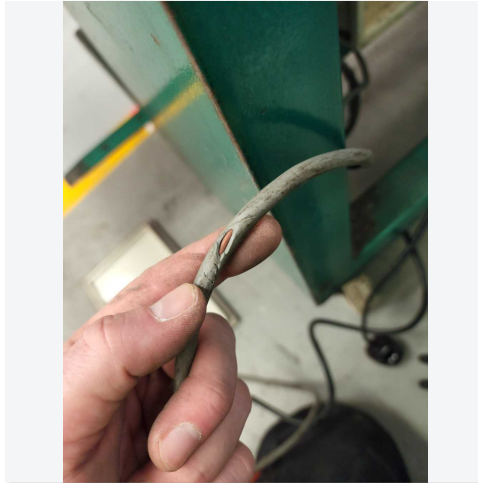
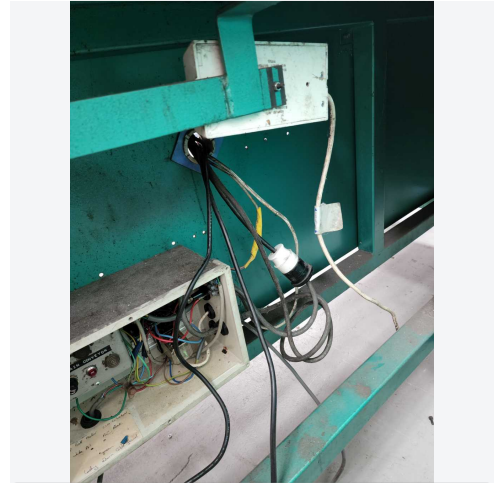
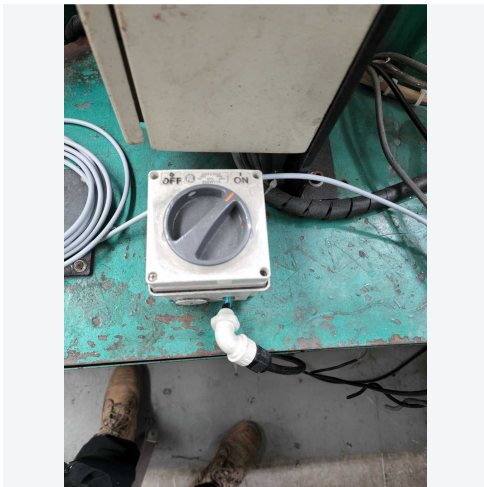
Photo Evidence

No safety air dump valve or associated safety relay fitted.

Unlabelled emergency stop button

There is an emergency stop button located behind the new guarding.

The machine automatically starts upon release of the emergency stop.

Gate sensors are detached and not currently functional due to the guarding installation.

The main switch is located within the guarded area

Damaged 230v mains cables

No main switch label

Fit safety air dump valve and safety relay. (complete)

Install the emergency stop button into a correct emergency stop button enclosure with a labeled collar. (complete)

Relocate the emergency stop to outside the guarded work area. (complete)

Install a start-stop button and incorporate the emergency stop button through the safety relay. (complete)

Reinstate the gate sensors with the addition of an extra sensor for the double slide doors. (complete)

Relocate the main Switch to a safe location (complete)

Label the main switch (complete)

Replace damaged cables (complete)
